EXECUTIVE SUMMARY

OBSERVATIONS & RECOMMENDATIONS

Governor's Lake, Raymond

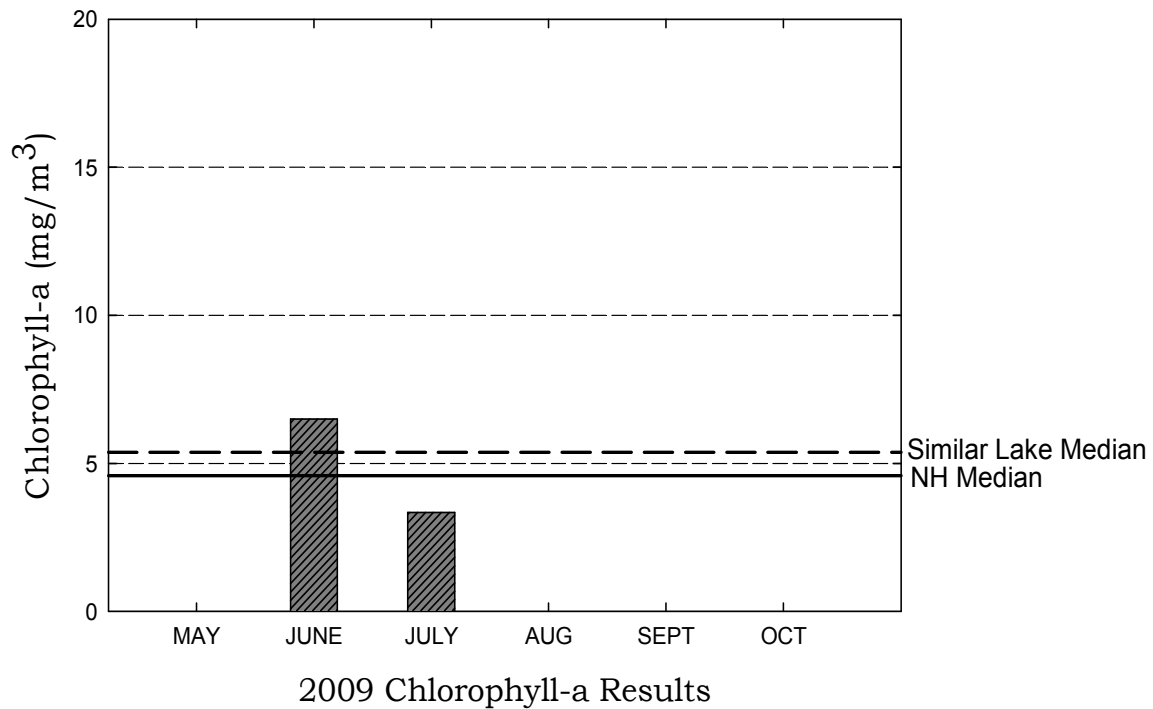
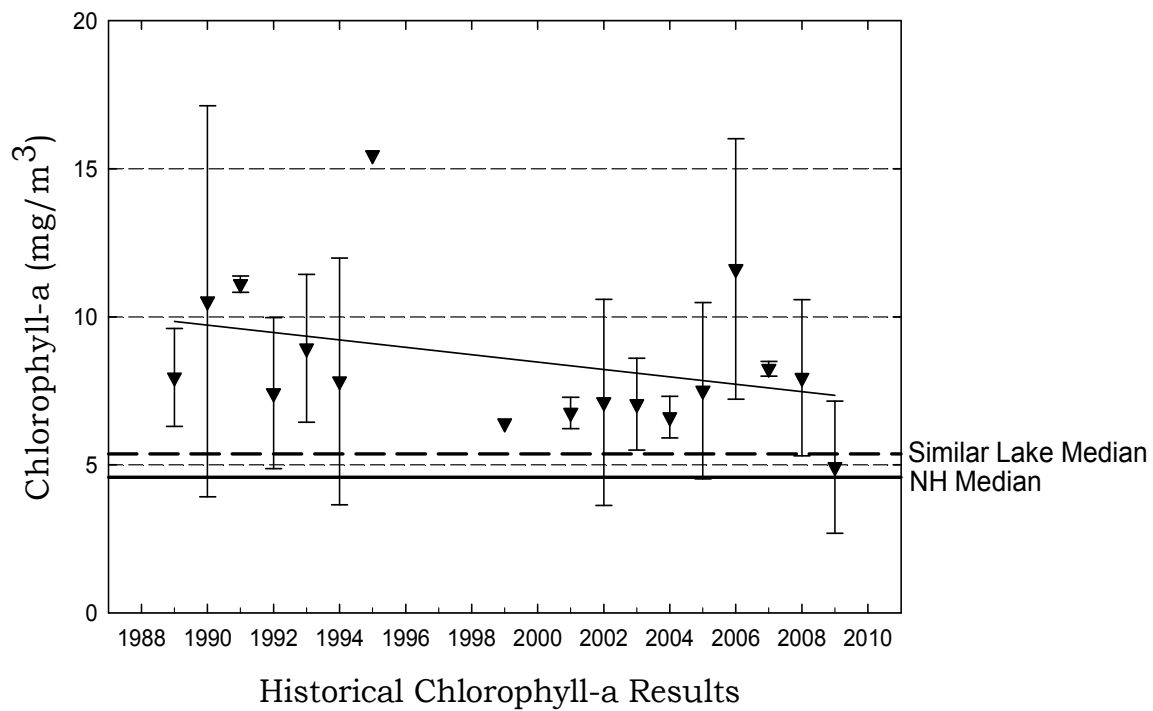
Figure 1. Monthly and Historical Chlorophyll-a Results

Figure 1 depicts the historical and current year chlorophyll-a concentration in the water column.

The current year data (the top graph) show that the chlorophyll-a concentration **decreased** from **June** to **July**.

The historical data (the bottom graph) show that the **2009** chlorophyll-a mean is **slightly greater than** the state median and is **slightly less than** the similar lake median, and is the lowest (best) mean chlorophyll-a concentration since monitoring began. For more information on the similar lake median, refer to Appendix D.

Overall, visual inspection of the historical data trend line (the bottom graph) shows a **variable** in-lake chlorophyll-a trend since monitoring began. Specifically the mean chlorophyll concentration has **fluctuated between approximately 4.92 and 22.61 mg/m³** since **1989**.

While algae are naturally present in all waterbodies, an excessive or increasing amount of any type is not welcomed. Phosphorus is the nutrient that algae typically depend upon for growth in New Hampshire lakes and ponds. Algal concentrations increase as nonpoint sources of phosphorus from the watershed increase, or as in-lake phosphorus sources increase. Increased Chlorophyll-a concentrations can also affect water clarity, causing Secchi-disk transparency to decrease (worsen) and turbidity to increase (worsen). Therefore, it is extremely important for volunteer monitors to continually educate all watershed residents about management practices that can be implemented to minimize phosphorus loading to surface waters.

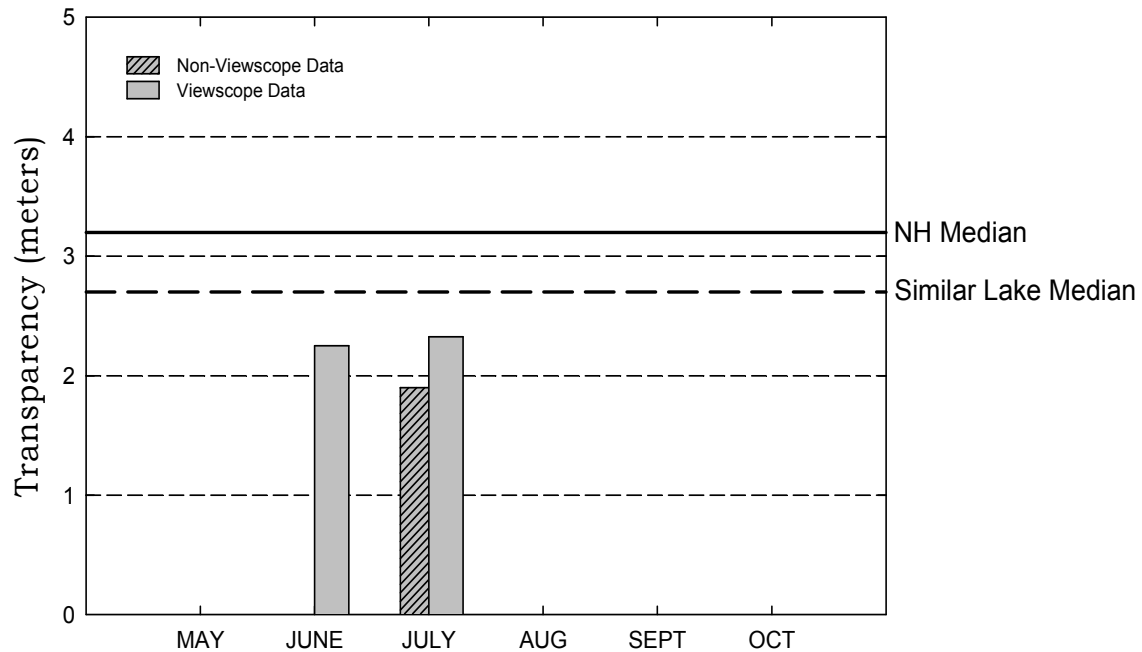
2009 Transparency Viewscape and Non-Viewscope Results

Figure 2 depicts the historical and current year transparency *with and without* the use of a viewscope.

The current year *non-viewscope* in-lake transparency was **1.9 meters in July**.

The current year *viewscope* in-lake transparency *increased slightly* from **June** to **July**.

The transparency measured with the viewscope was generally *greater than* the transparency measured without the viewscope this summer. A comparison of the transparency readings taken with and without the use of a viewscope shows that the viewscope typically increases the depth to which the Secchi disk can be seen into the lake, particularly on sunny and windy days. We recommend that your group measure Secchi disk transparency with and without the viewscope on each sampling event.

Typically, high intensity rainfall causes sediment-laden stormwater runoff to flow into surface waters, thus increasing turbidity and decreasing clarity. Efforts should continually be made to stabilize stream banks, pond shorelines, disturbed soils within the watershed, and especially dirt roads located immediately adjacent to the edge of tributaries and the pond. Guides to best management practices that can be implemented to reduce, and possibly even eliminate, nonpoint source pollutants, are available from DES upon request.

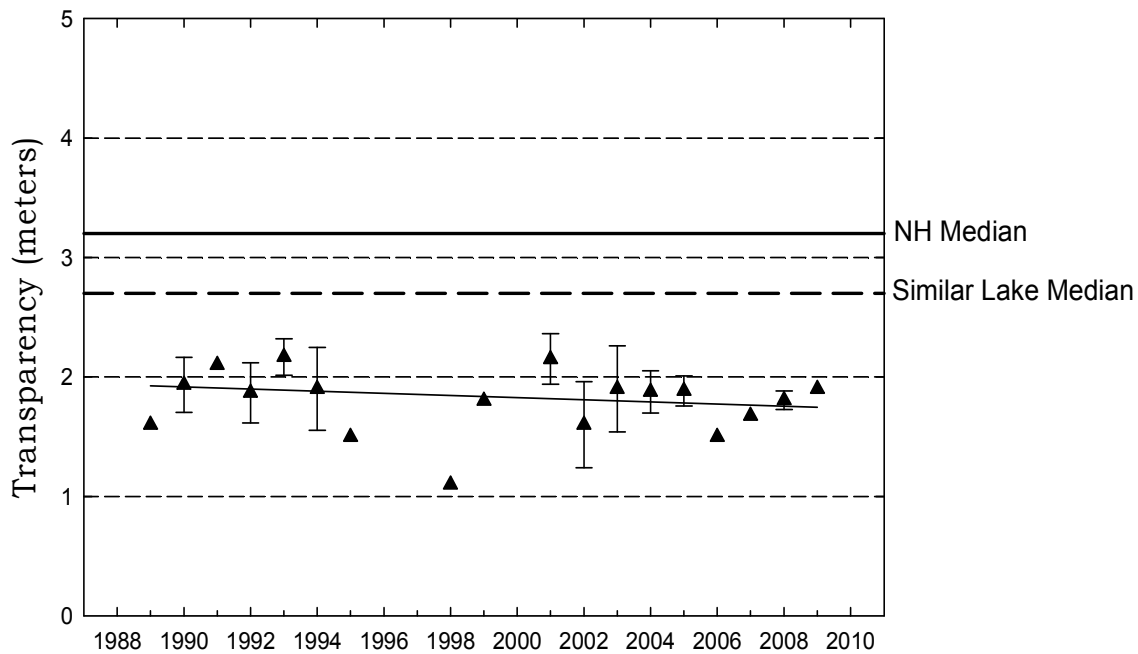
Historical Transparency Non-Viewscope Results

The historical data (the bottom graph) show that the **2009** mean non-viewscope transparency is *less than* the state and similar lake medians. Please refer to Appendix D for more information about the similar lake median.

Visual inspection of the historical data trend line (the bottom graph) shows a *stable* trend. Specifically, the transparency has *remained relatively stable ranging between 1.10 and 2.17 meters* since monitoring began in **1989**.
